## Assessment of Environmental and Economic Benefits Associated with Streambank Stabilization and Phosphorus Retention

by Lisa C. Hubbard, David S. Biedenbarn,  
and Steven L. Ashby

**PURPOSE:** This technical note documents the assessment of potential water quality improvements and economic impacts associated with streambank stabilization and phosphorus retention. Phosphorus (P) comes from both point sources (e.g., sewage effluents and industrial discharge) and nonpoint sources (e.g., urban, agricultural, and forest runoff). Measures to control point source pollution (e.g., constraints on P-based inputs) were implemented with the 1972 U.S. Clean Water Act. Recent environmental management efforts have focused on the control of nonpoint sources of contaminants. Erosion and subsequent transport of sediment-bound phosphorus from streambanks can provide a major source of bioavailable phosphorus to aquatic systems. Reduction in the availability of phosphorous (and sediment, and nitrogen), associated with streambank stabilization provides potential economic benefits through reduced treatment costs and adverse environmental impacts. Recent studies in the Demonstration Erosion Control (D

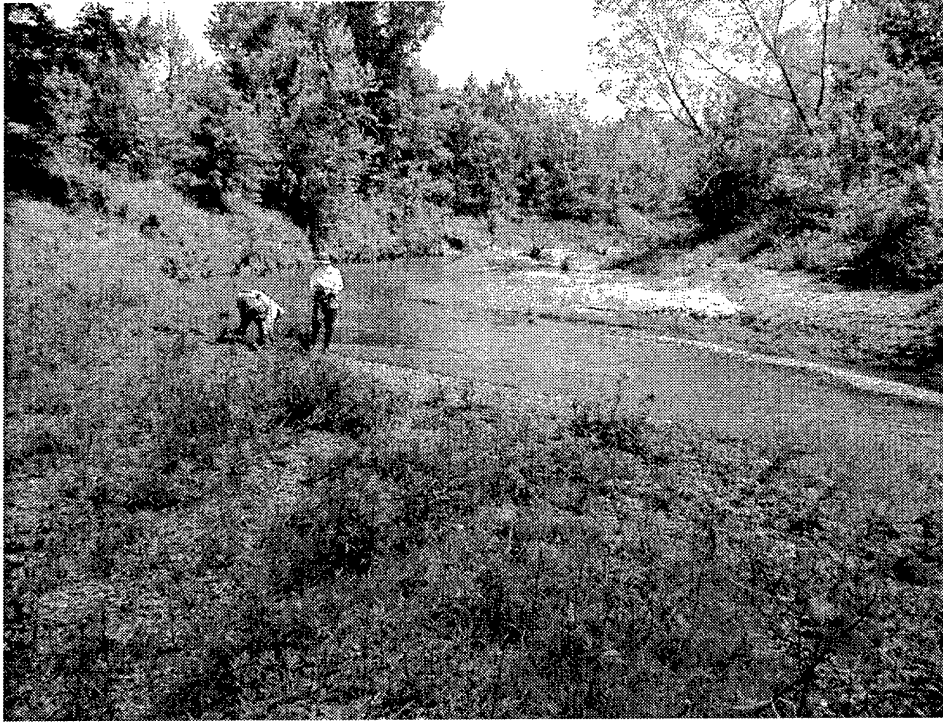
Figure 3. Reach 11, bendway weir site

**Geomorphic Status of Harland Creek Post Stabilization.** After nine years, the bendway weir and longitudinal peaked stone toe sites viewed during the field investigation seemed to be performing adequately with minimal bank erosion. Figure 3 shows an example of the stable banks with vegetation successfully colonizing and maturing. There are a few sites where raw banks were visible directly next to bendway weirs, as seen in Figure 4. However the majority of the raw banks appear to coincide with the willow post sites, an example of which is seen in Figure 5. The raw banks at the willow post sites may be due in part to the low survival rates of the willow posts. According to Pokrefke et al. (1996), survival at the willow post sites was at 80 percent in spring of 1994 but dropped to 42 percent by October. By 2002 there is almost 100-percent mortality of the willow posts. Although some of the banks are raw, they have not retreated much as remnants of the willow posts are still visible. Field observation at these sites revealed that there has been erosion at the toe (1 to 2 ft). This is supported by a numerical model study conducted in 1999 that found the added roughness of the willow posts increases stress on the toe (Watson et al. 2001). While it is possible that the willow post remnants may be contributing to the stability of the banks, it is more likely that the historical erosion rates in these bends were lower due to the presence of resistant bank material and the longer radius of curvature bends.
